Manhole Inspection Summary

Manhole # S21C1_002MH

Insp Date: **5/22/08 8:39 AM**

Location Address: **2505 ridgely st**

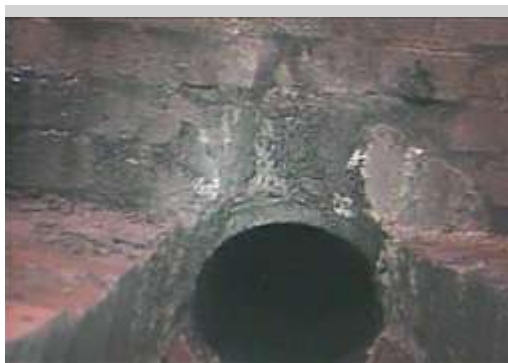
Defect 2

Infiltration: ☐ None ☐ Joint ☐ Cracks ☐ Mortar ☐ Roots ☒ **Wall**

infiltration @ barrel wall, above 12 oclock

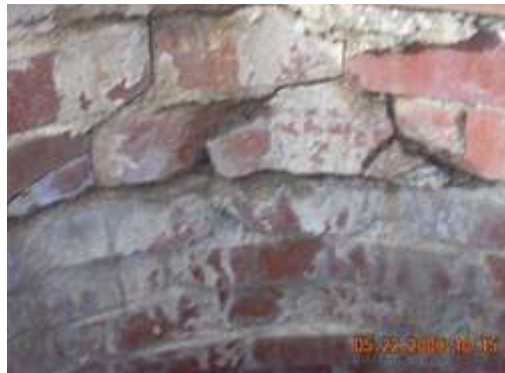
Defect 1

Condition: ☐ Sound ☒ **Cracked** ☐ Root Intrusion ☐ Loose Brick ☐ Deteriorated

cracked corbel bricks

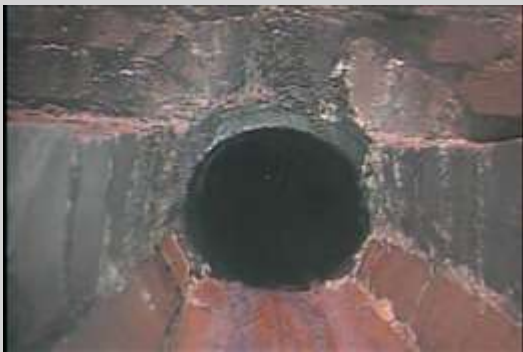
12 O'Clock Outflow

8 in. Circular Gravity Sewer
Pipe Out @ 12 O'Clock

Pipe Height: **8.4** (in.) Rod and Bar (Angled)
Pipe Material: **Clay** ☐ Pipe Lined
Invert Depth: **8.89** (ft.) Flow Characteristics: **Slow**
Deposits: ☒ None ☐ Mud ☐ Sludge ☐ Debris ☐ Grease
Silt Depth: **0** (in.) Deposits Extent:
Infiltration: **None** Pipe Seal Cond: **Sound**

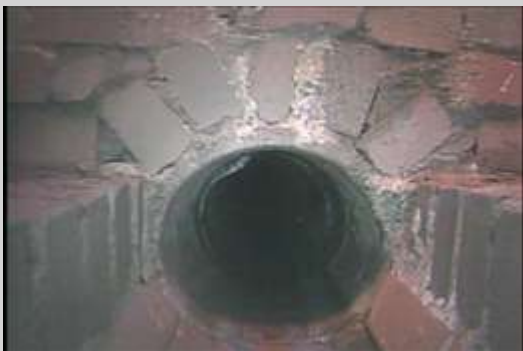
6 O'Clock Inflow

8 in. Circular Gravity Sewer
Pipe In @ 6 O'Clock

Pipe Height: **8.4** (in.) Rod and Bar (Angled)
Pipe Material: **Clay** ☐ Pipe Lined
Invert Depth: **8.80** (ft.) Flow Characteristics: **Slow**
Deposits: ☒ None ☐ Mud ☐ Sludge ☐ Debris ☐ Grease
Silt Depth: **0** (in.) Deposits Extent:
Infiltration: **None** Pipe Seal Cond: **Sound**
